MASON-DALLAS .INC

NEWSLETTER

HVAC
EDITION

The Call of Last Resort!

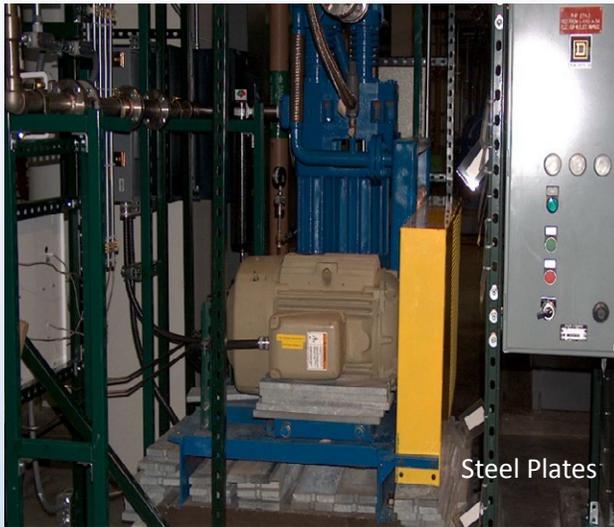
Cornerstone next tried adding 1,300 lbs. of more mass to our base by stacking 57 pieces of ¾" x 6" x 18" steel plates under and around the motor. (See photo above) While the effects were measurable, the amplitudes remained well

above acceptable levels.

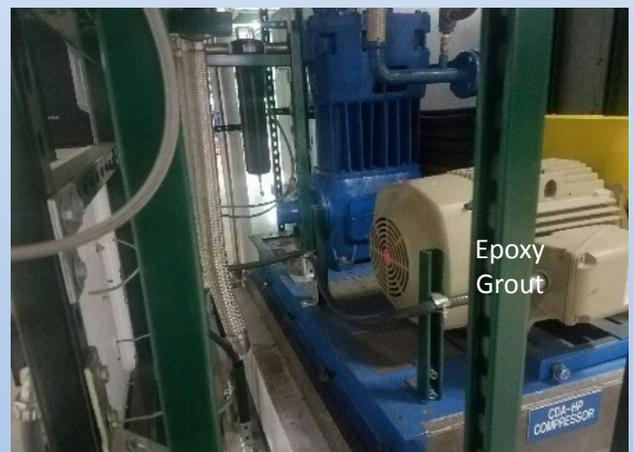
We noticed the motor and compressor were supported by a structural steel angle base bolted to our inertia base. The steel support members under the motor and compressor were approximately 7 inches above our inertia base. When the compressor was in operation, this steel base support resonated excessively. This is what we believed to be the problem.

We recommended to fill the 7-inch void under the compressor and motor with Epoxy grout to eliminate the structural resonance and flexing. (See photo to the right). Then once the grout cured, readjust the spring mounts to the design spring deflection and the 2-inch operating clearance under the inertia base.
