Getting to the Core of the Issue

Flectrical Switchgear

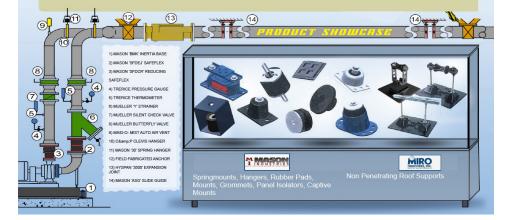
What we noticed inside the unit is pretty much what we have seen in all our inspections of switchgear transformers throughout the years. The transformer sat on rubber pads, which rested on structural steel members that were an integral part of the unit's perimeter steel base. The enclosure panels were then directly connected to the perimeter steel base.

Even though the transformer was isolated using rubber pads, those pads were resting on the unit's steel base. Therefore, the pads were doing little to prevent the vibratory energy from traveling through the steel support to the structure.

In addition, since the structural steel supporting the transformer was also attached to the steel perimeter, the energy in the support steel excited the perimeter panels and added even more energy to vibration and noise conditions.

To solve the issue we designed a saddle support system using a steel plate, brackets and specially compounded neoprene mounts. After approval of our design by both the engineer and the manufacturer, we then effectively lifted the transformer off the structural steel support with the saddles and positioned the neoprene mounts on the concrete floor. By doing so, we now had the

transformer core entirely off the structural steel base, using the resiliency of the neoprene mounts and the mass and dampening of the concrete floor to resolve the issue.

The design worked perfectly and the vibration and noise was eliminated. Thanks to Mr. Brady's call for help, we have continued to use the saddle and bracket approach on other projects with the same challenges. Over the years we have solved similar problems in Dallas, Irving, Houston, Southlake and New Orleans, for our clients.
